# U-6A / NU-1B Technical Support Contract

## Aircraft Inspection Report

December 19, 2003

Document Number: 2003 NU-1B 0001

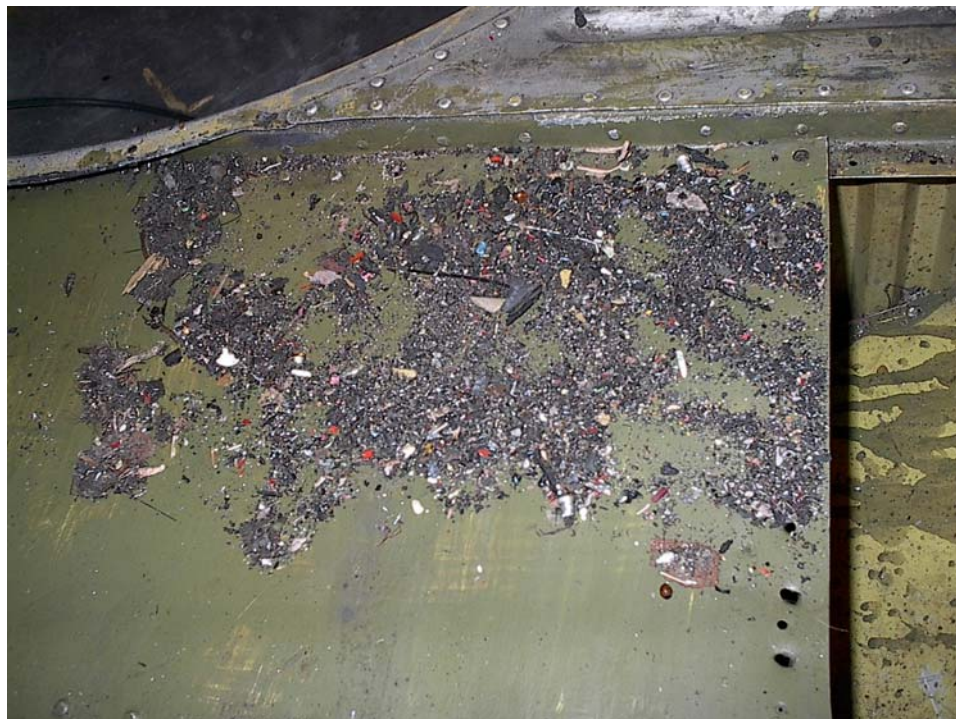
**5.4.1.39. Dirt and FOD found under cabin sub floor.**

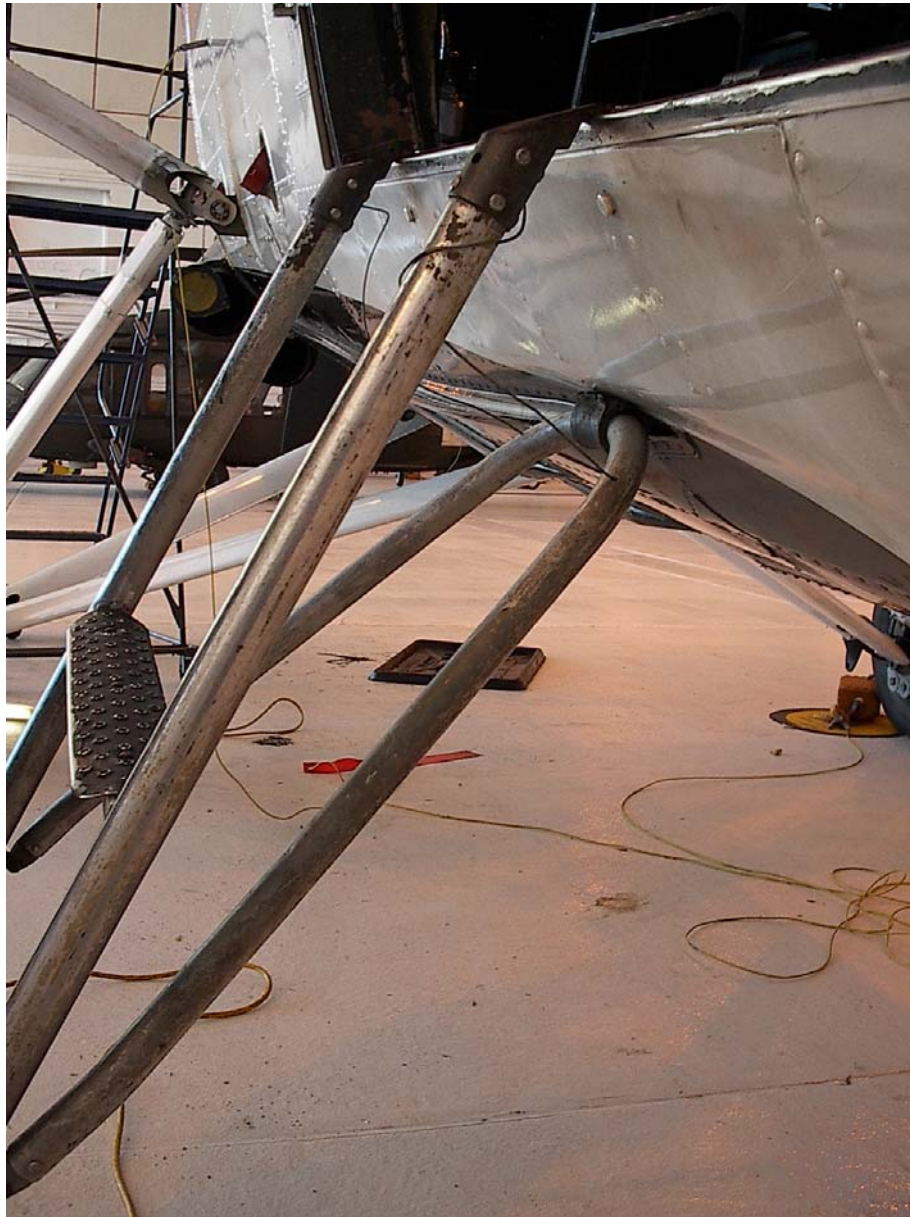
**5.4.1.40. Fuselage contact point for airstairs has internal damage, airstairs deform fuselage skin when weight is put on the stairs.**

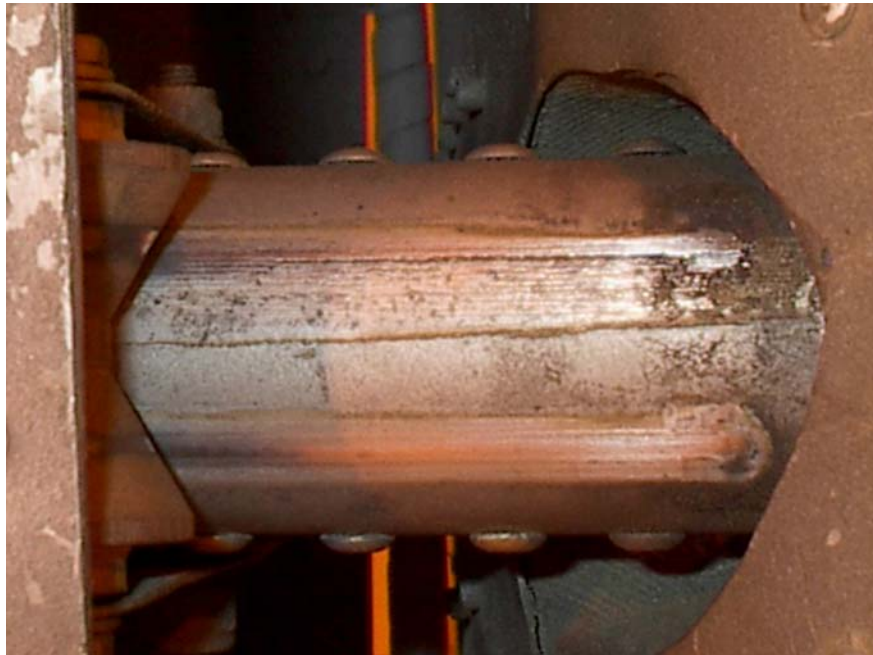
- 5.4.2.1. **Possible Stress cracks on inboard flap push-pull control rod (Flap System) near rollers. Inb. of wing. CRITICAL**

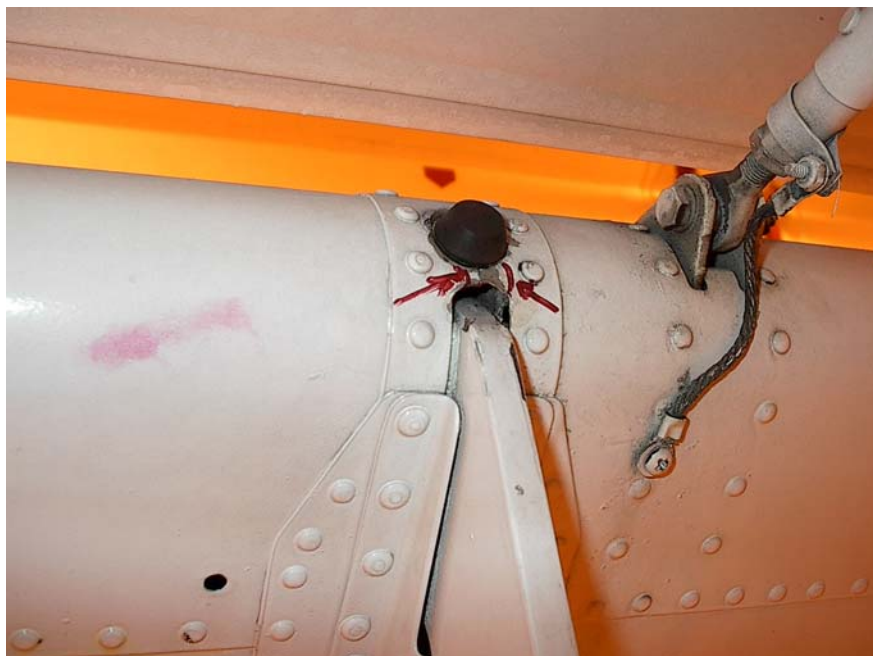
- 5.4.2.2. **RH inboard fore flap stop bumper deteriorating and double plate is cracked**

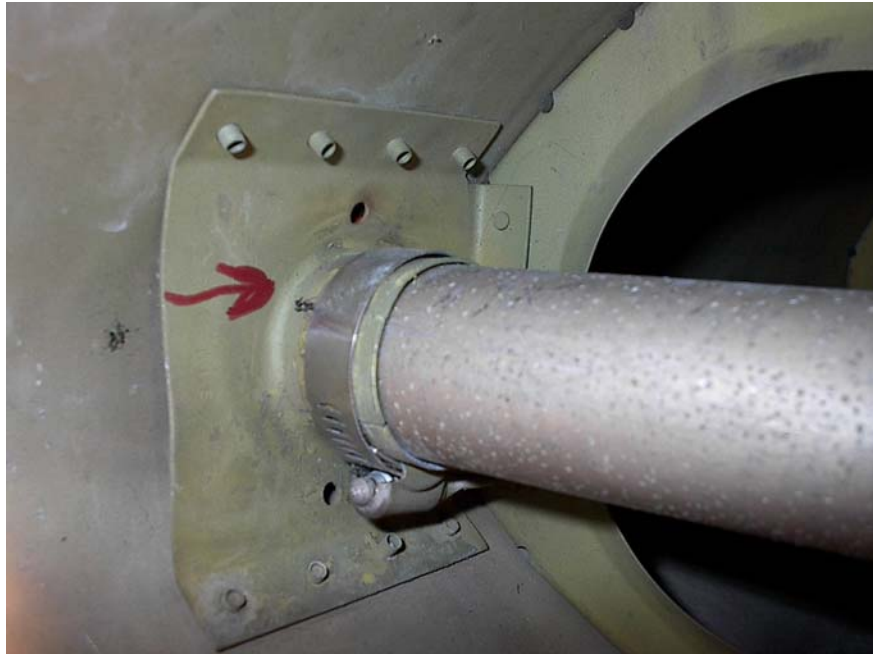
5.4.2.4. **Wing 3 --- LH wing pitot mast support bracket cracked inside the wing leading edge.**

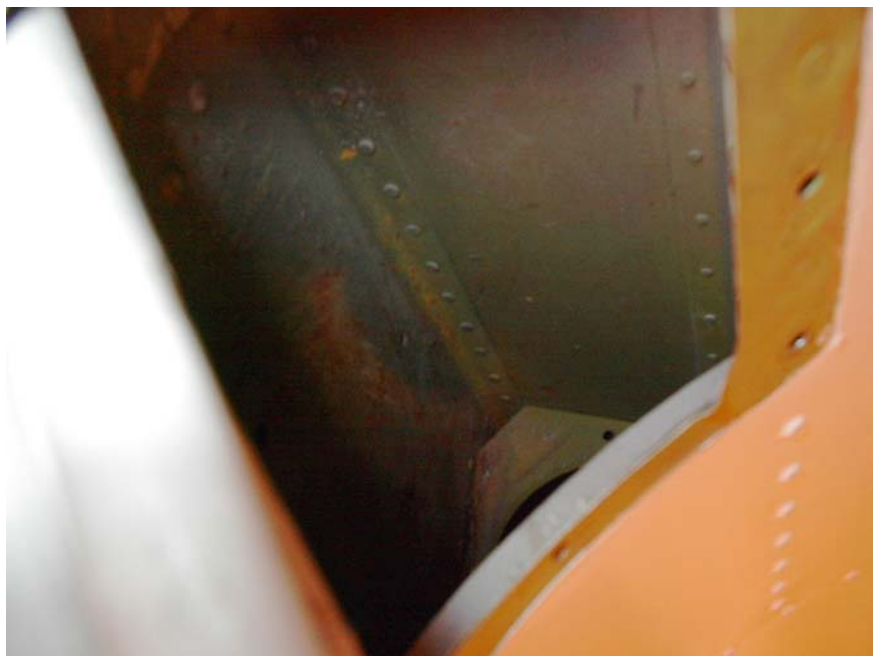
5.4.2.5. **Some surface corrosion starting on R/H and L/H rear spar outboard of wing STN 247 pic. 87**

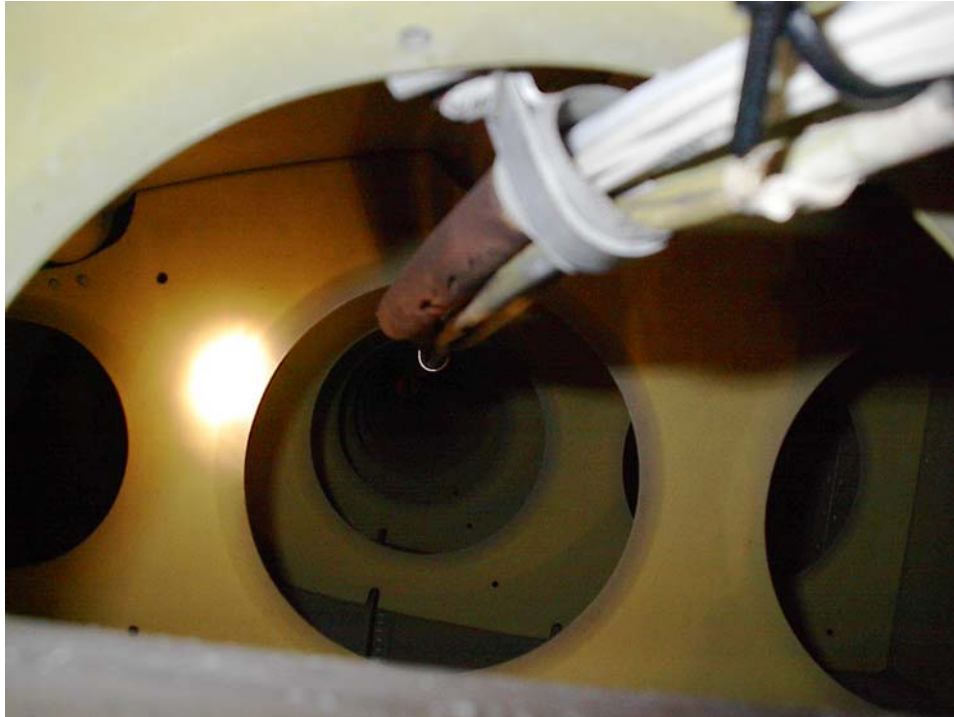
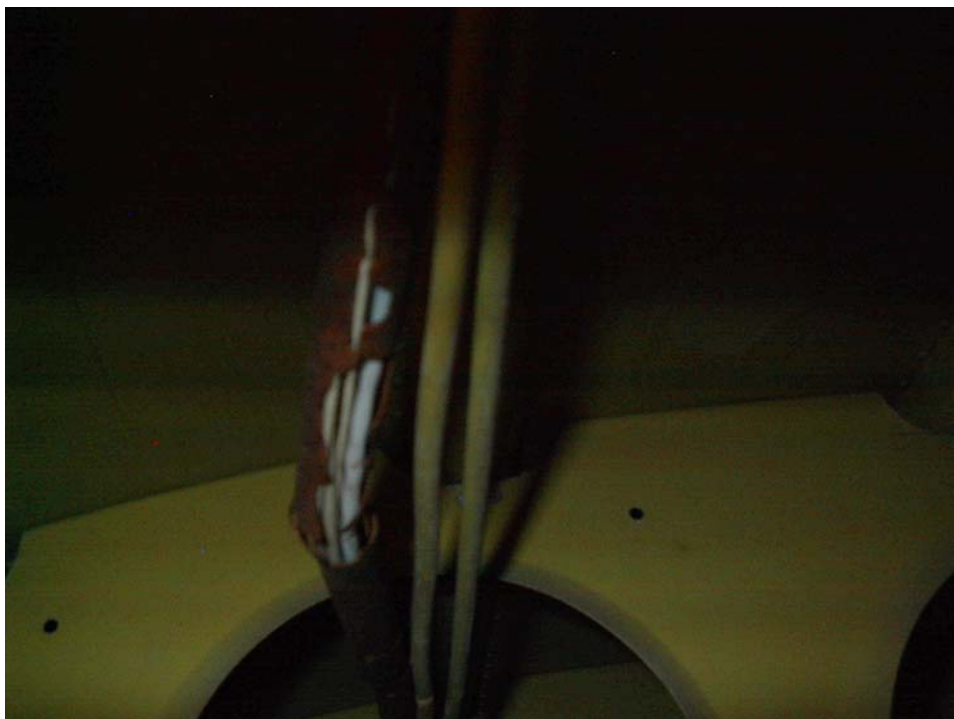
5.4.2.7. **Wing electrical conduit cracked and broken inside LH outboard wing.**

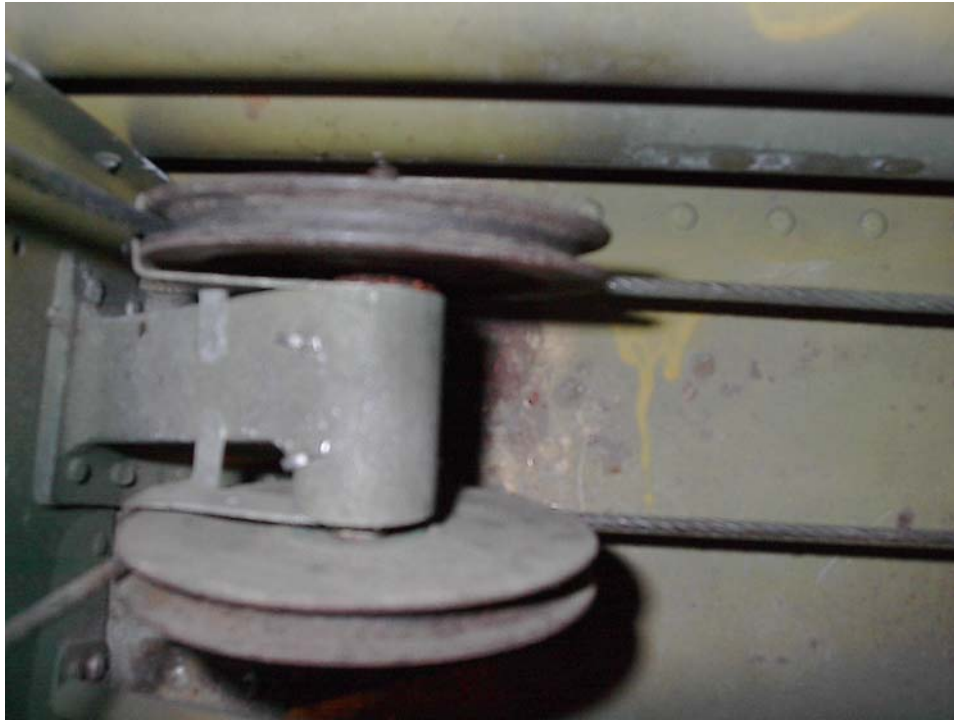
**5.4.2.8. LH wing outboard aileron pulleys worn and corroded.**

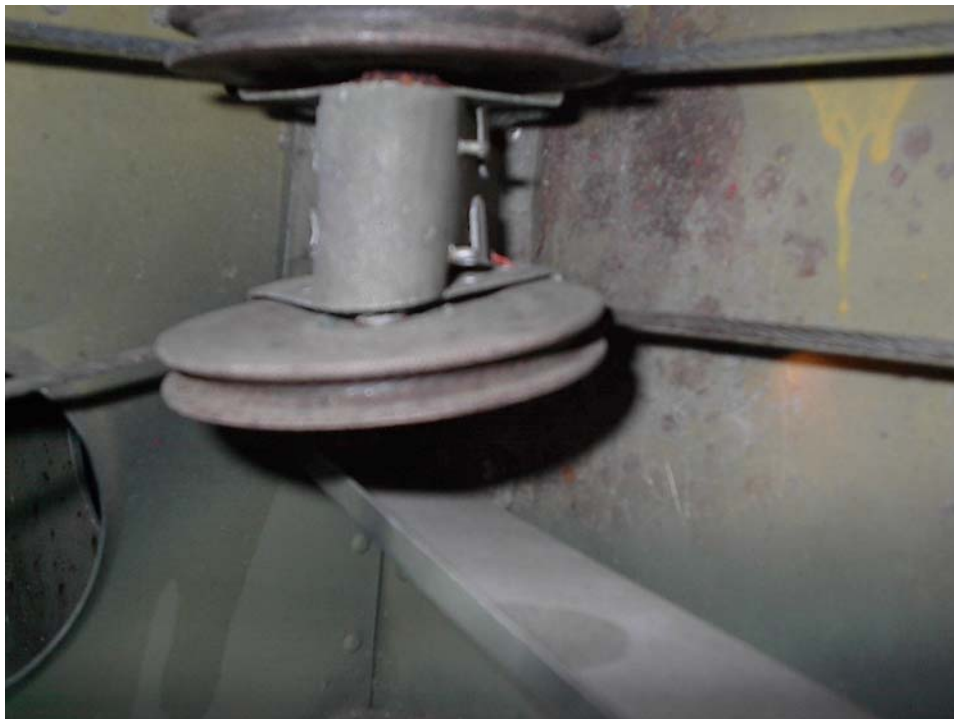
**5.4.2.9. LH wing outboard front spar has surface corrosion next to the pulley bracket.**

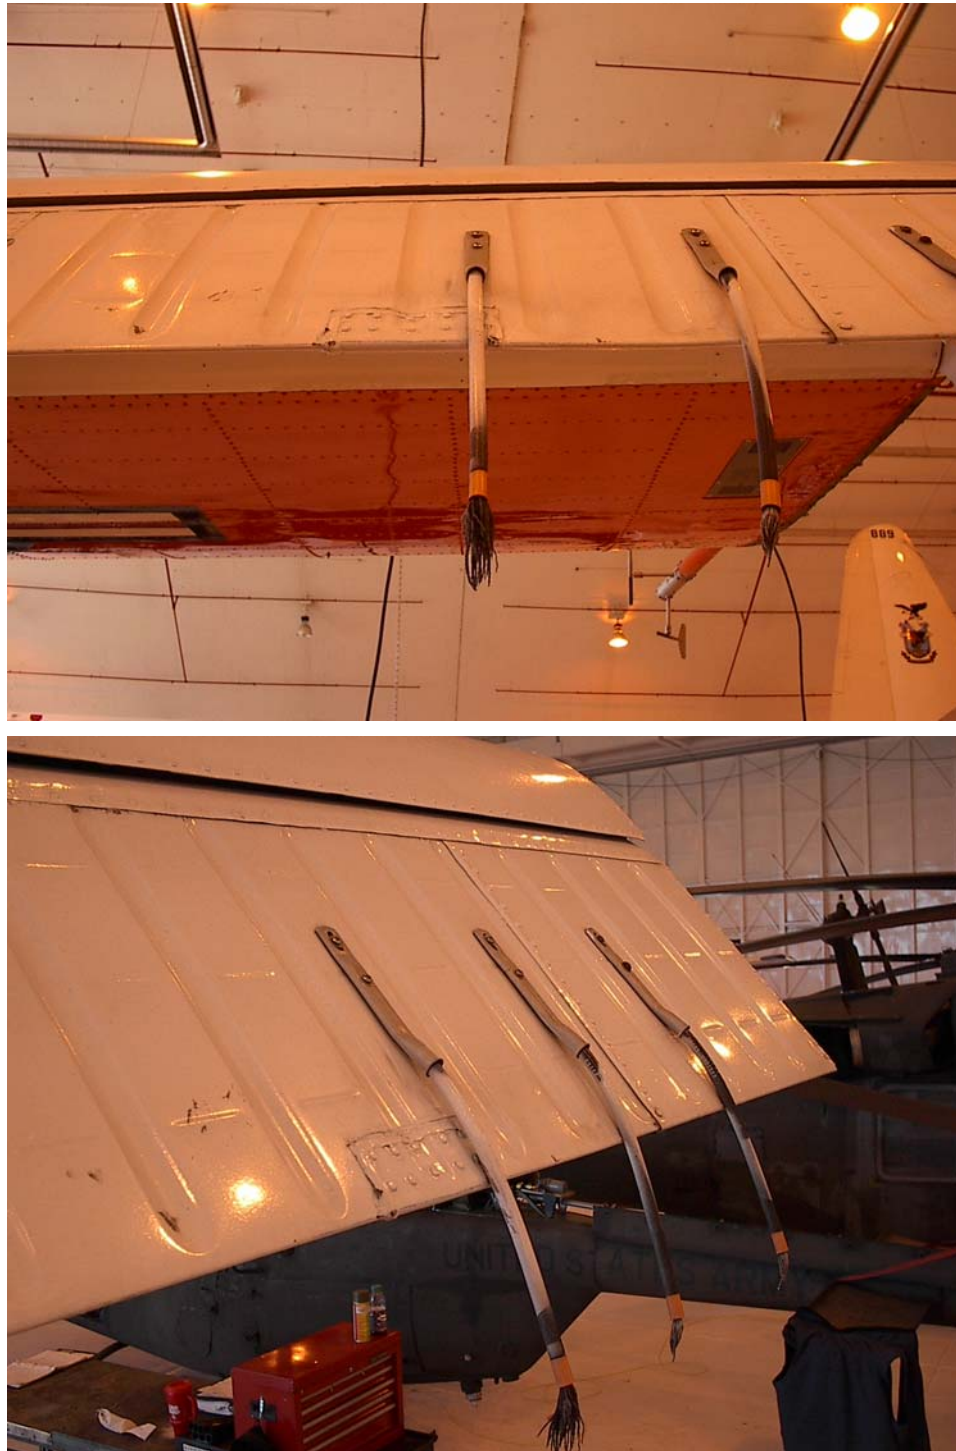
**5.4.2.10. Paint missing on R/H aileron top surface and unapproved repair to T/E of skin.**

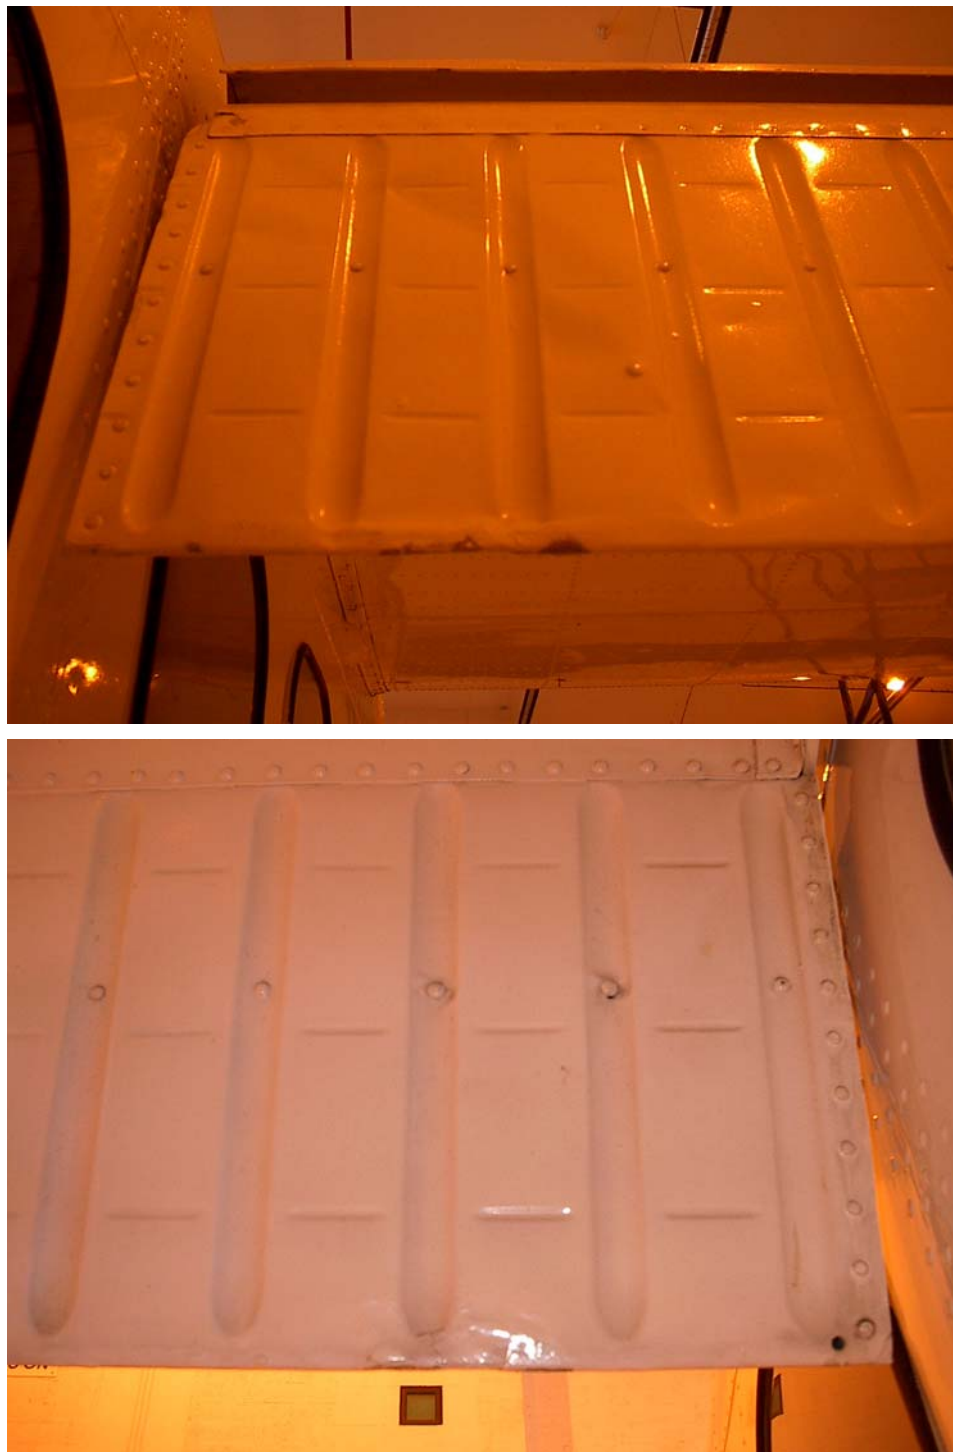
**5.4.2.11. Damaged skin on R/H inboard aft flap assembly**

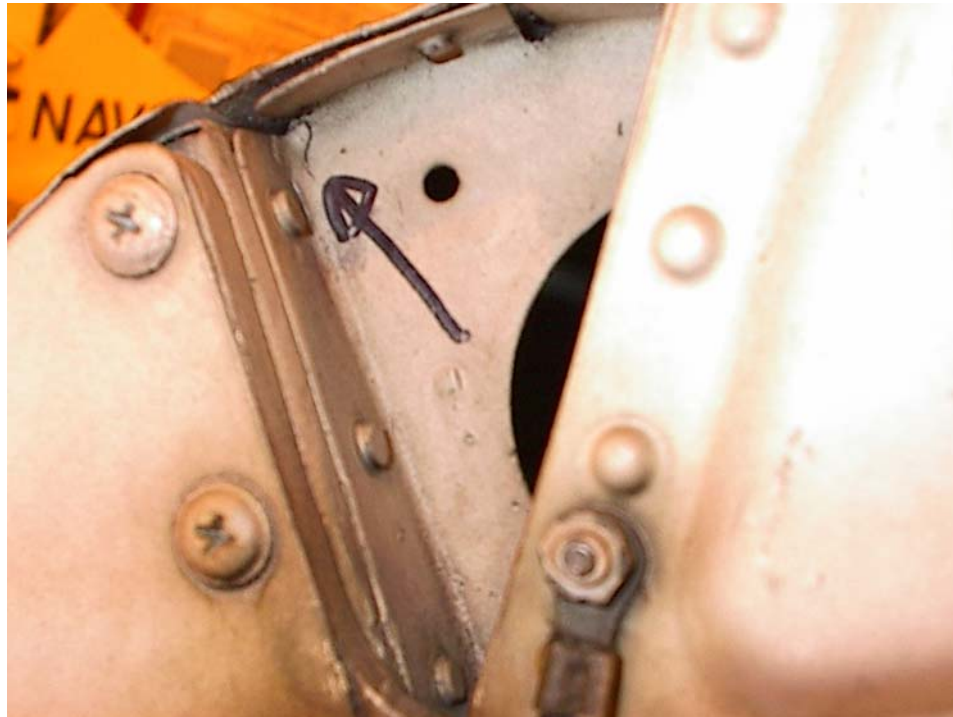
**5.4.2.12. R/H and L/H outboard leading edge ribs are cracked.**

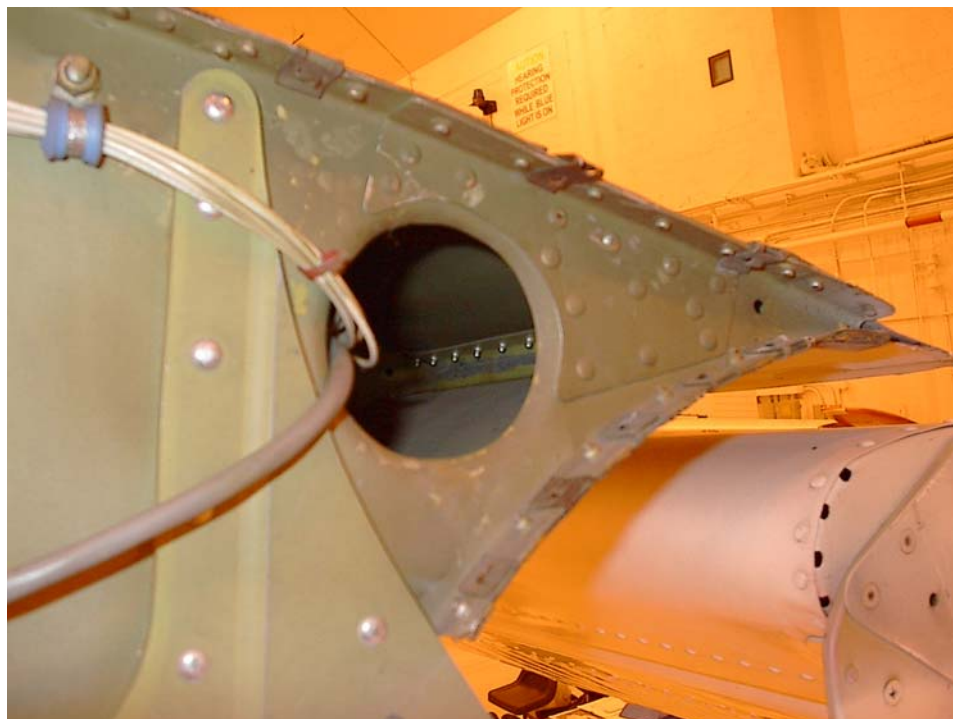
**5.4.2.13. LH wing has non standard repair on the outboard wing tip rib.**

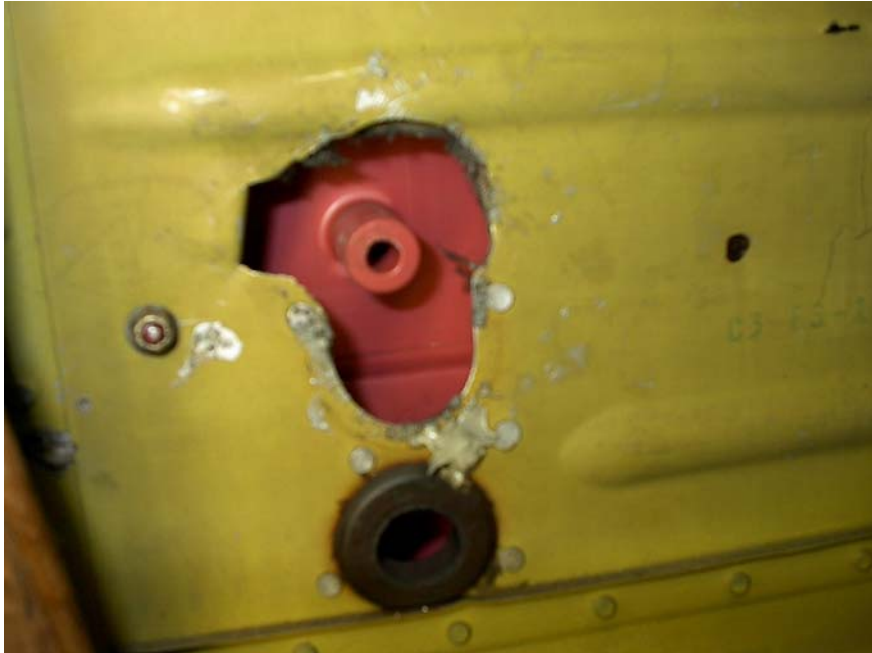
#### 5.4.3.1. **Poor sheet metal practices at rear battery vent station #308.**

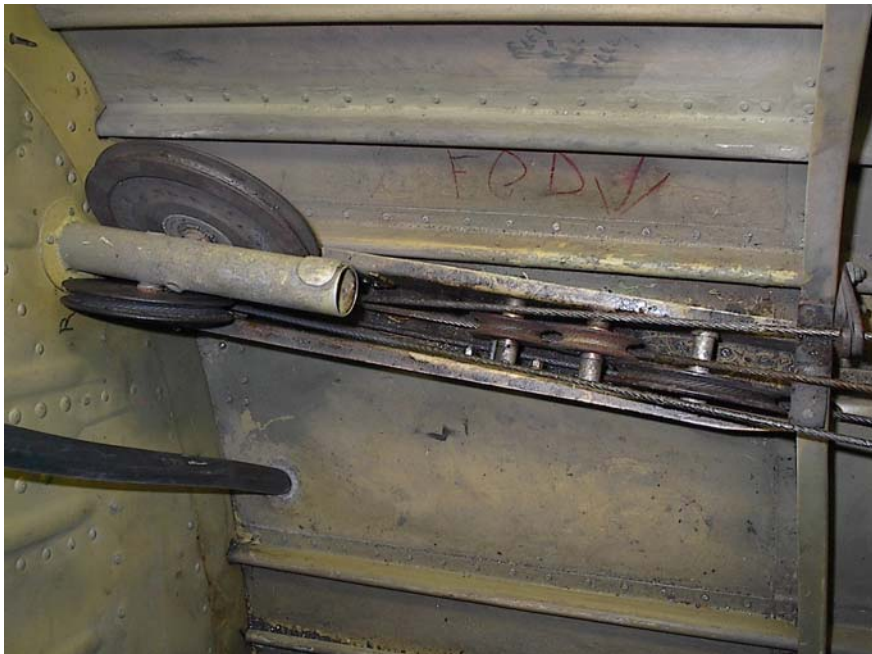
#### 5.4.3.2. **Elevator and rudder trim cable pulleys worn and grooved at trim cable support bracket station #320**

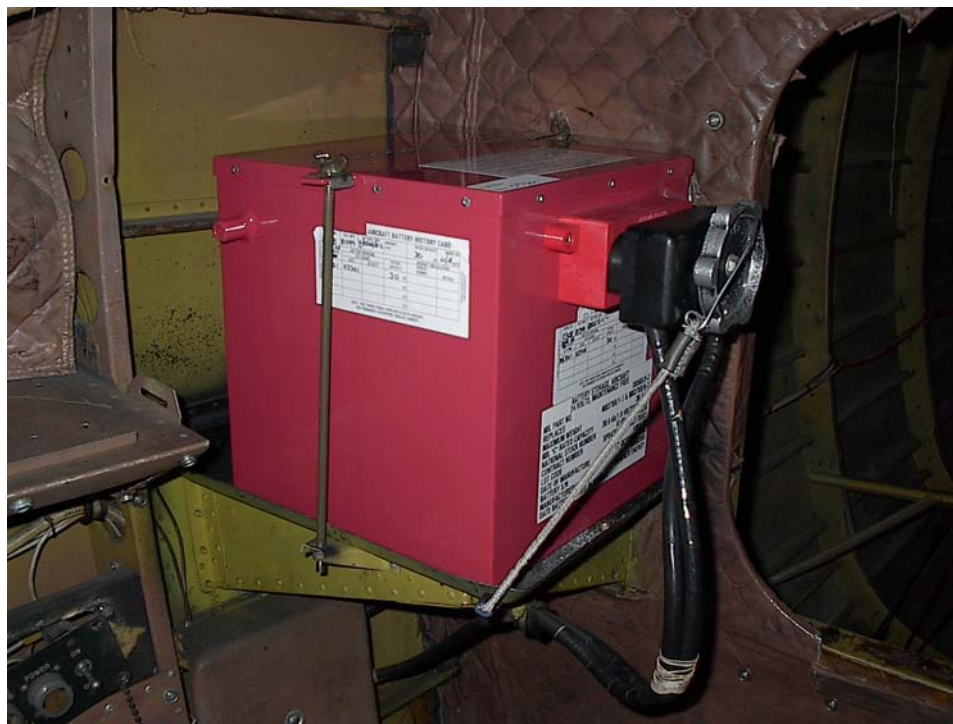
- 5.4.3.3. **Extensive cracks in upper LH corner of bulkhead assembly. Pin-C3FS12-37 at station # 427.38 No repair scheme for damaged bulkhead (no picture)**
- 5.4.3.4. **Cracks propagating from previously repaired area in upper RH corner of bulkhead pin-C3FS12-37 at station #427.38 (no picture)**
- 5.4.3.5. **Rudder quadrant assembly bearings “dry” and require lubrication pin-B538 (no picture)**
- 5.4.3.6. **Elevator and rudder control cable pulleys worn and required replacement at mount bracket pin C3FS174-11 station #308 (no picture)**
- 5.4.3.7. **Elevator trim tab assemble is not modified to recommended configuration of trim tab with mass balance weight mod # 3/909 (no picture)**
- 5.4.3.8. **Unapproved battery installation (non certified) inside AFT fuselage battery tray. Only 1 vent tube hooked up. 1 vent tube left open**

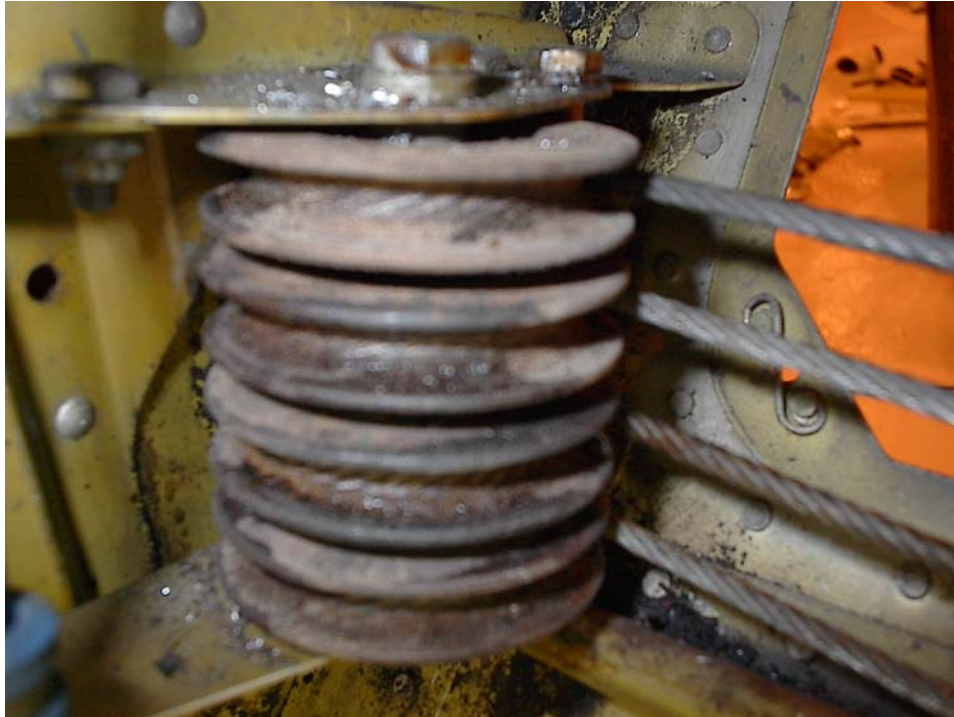
**5.4.3.9. Control cables pulleys worn and grooved at station #264 RH side**

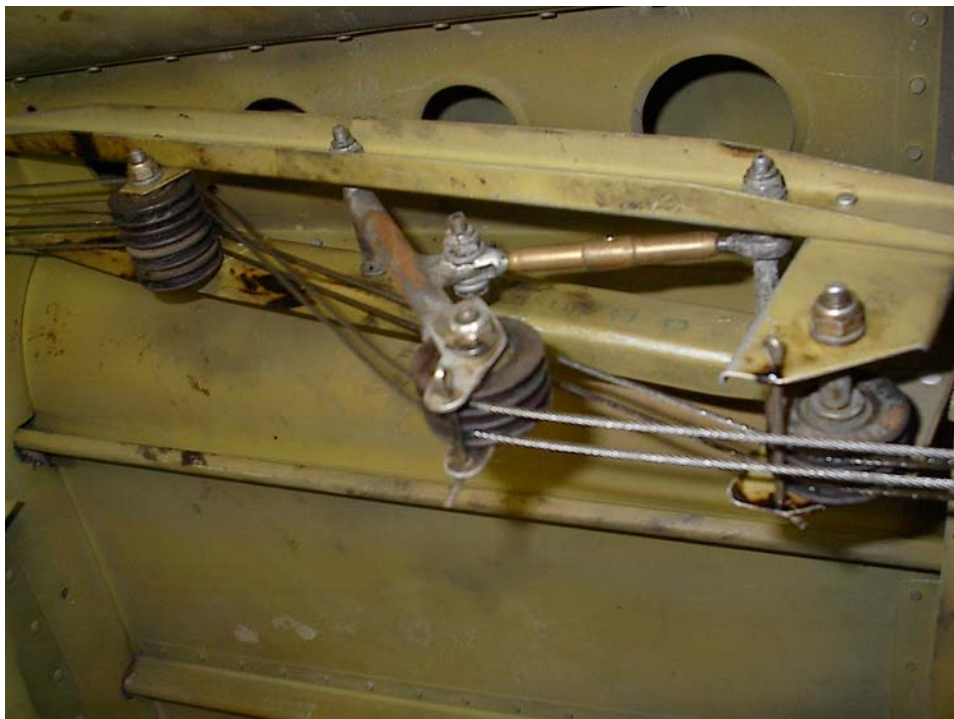
**5.4.3.10. Worn and grooved control cable pulleys in pulley mount cluster station #305**

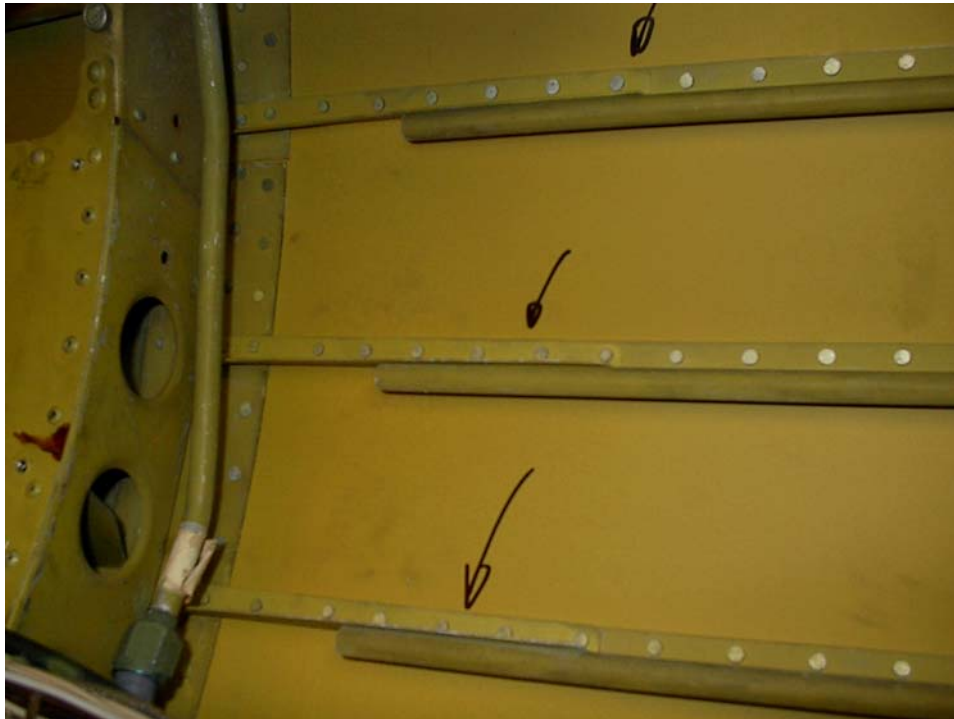
**5.4.3.11. Unapproved stringer repairs on R/H side fuselage aft of STN 264. Not I.A.W. SRM pg. 70 fig.4-16 (7 stringers in total)**

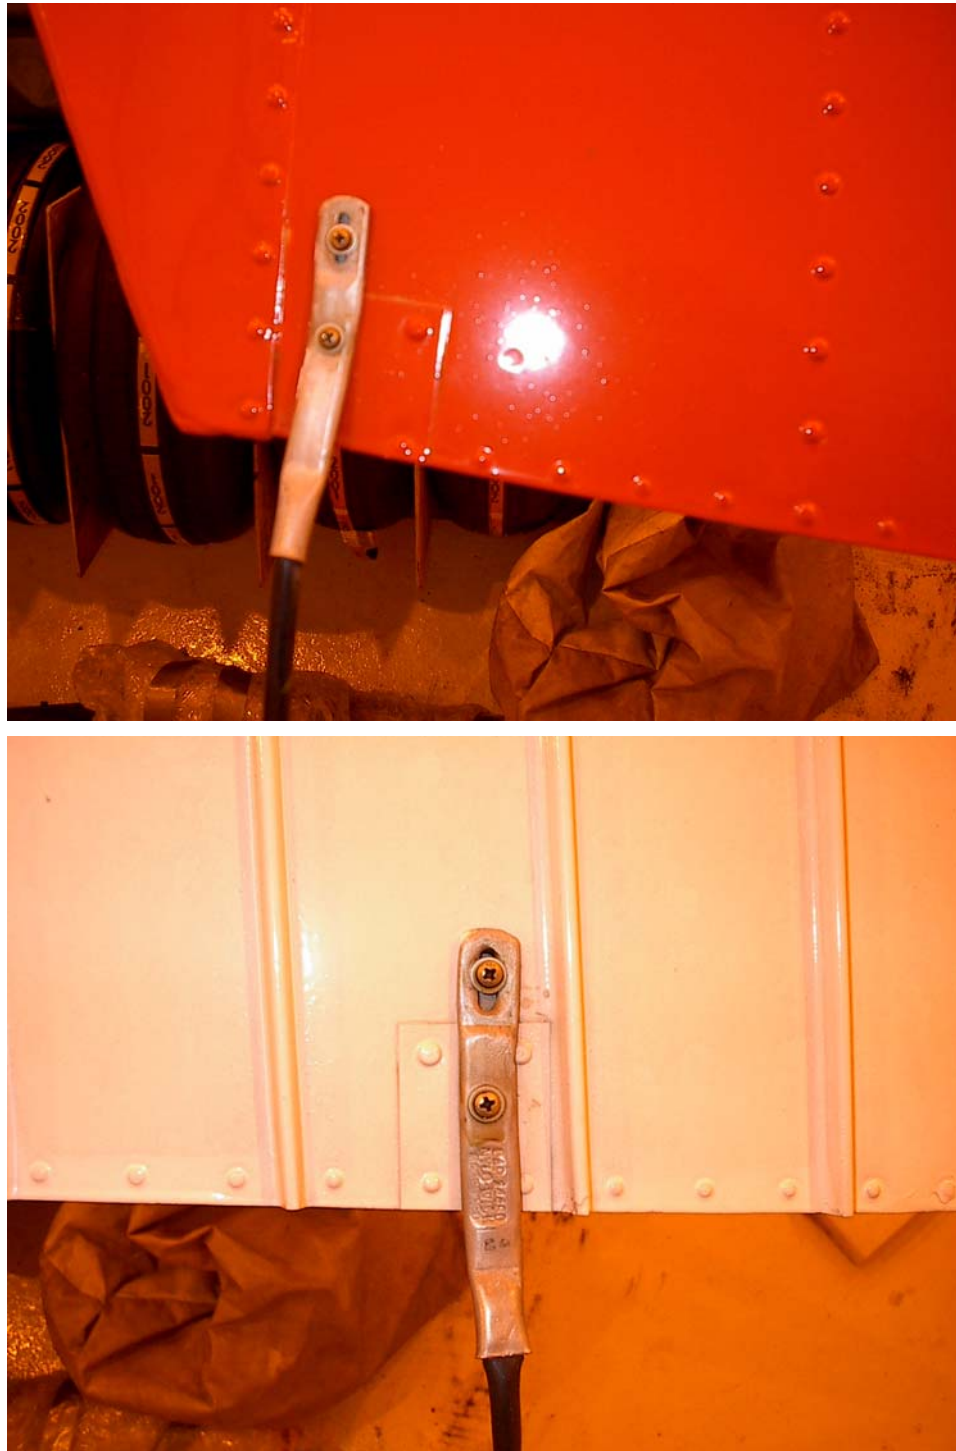
**5.4.3.18. Non-standard (unapproved repairs) on upper LH elevator skin at the trailer edge**

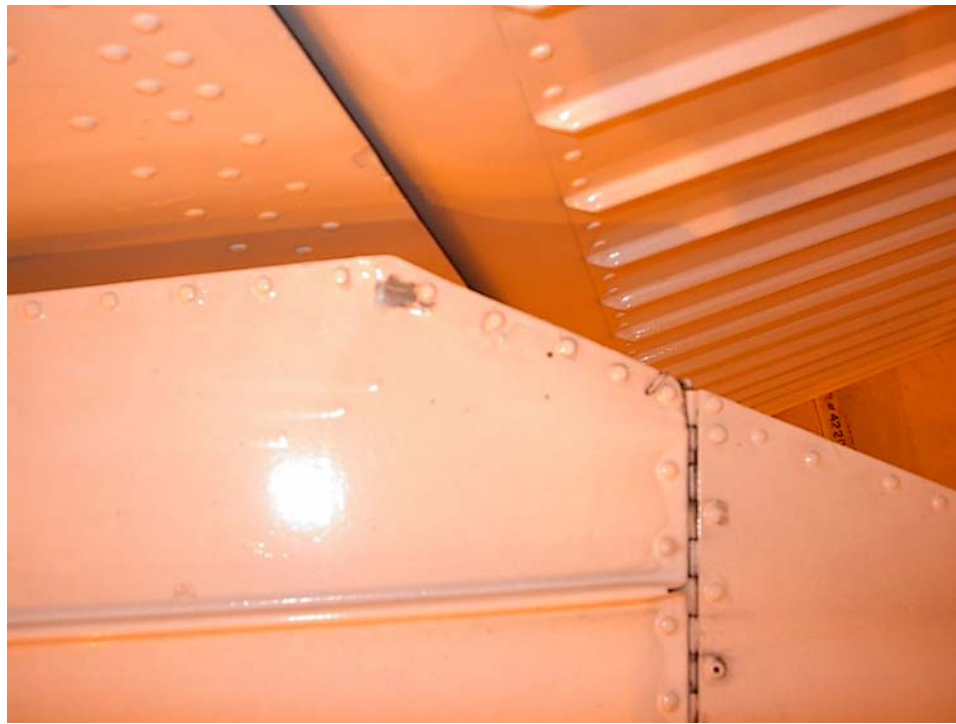
**5.4.3.19. LH elevator inboard top skin has multiple layers of cracked and peeling paint making crack detection difficult.**

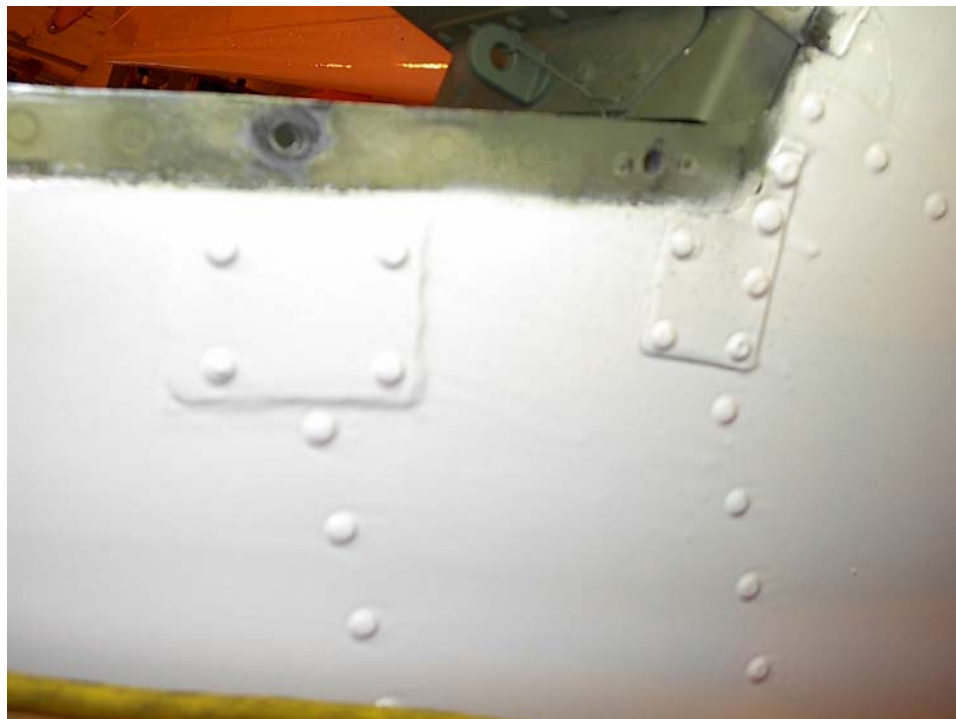
**5.4.3.20. Non-standard repair on LH side of dorsal fin next to rear lifting lug.**

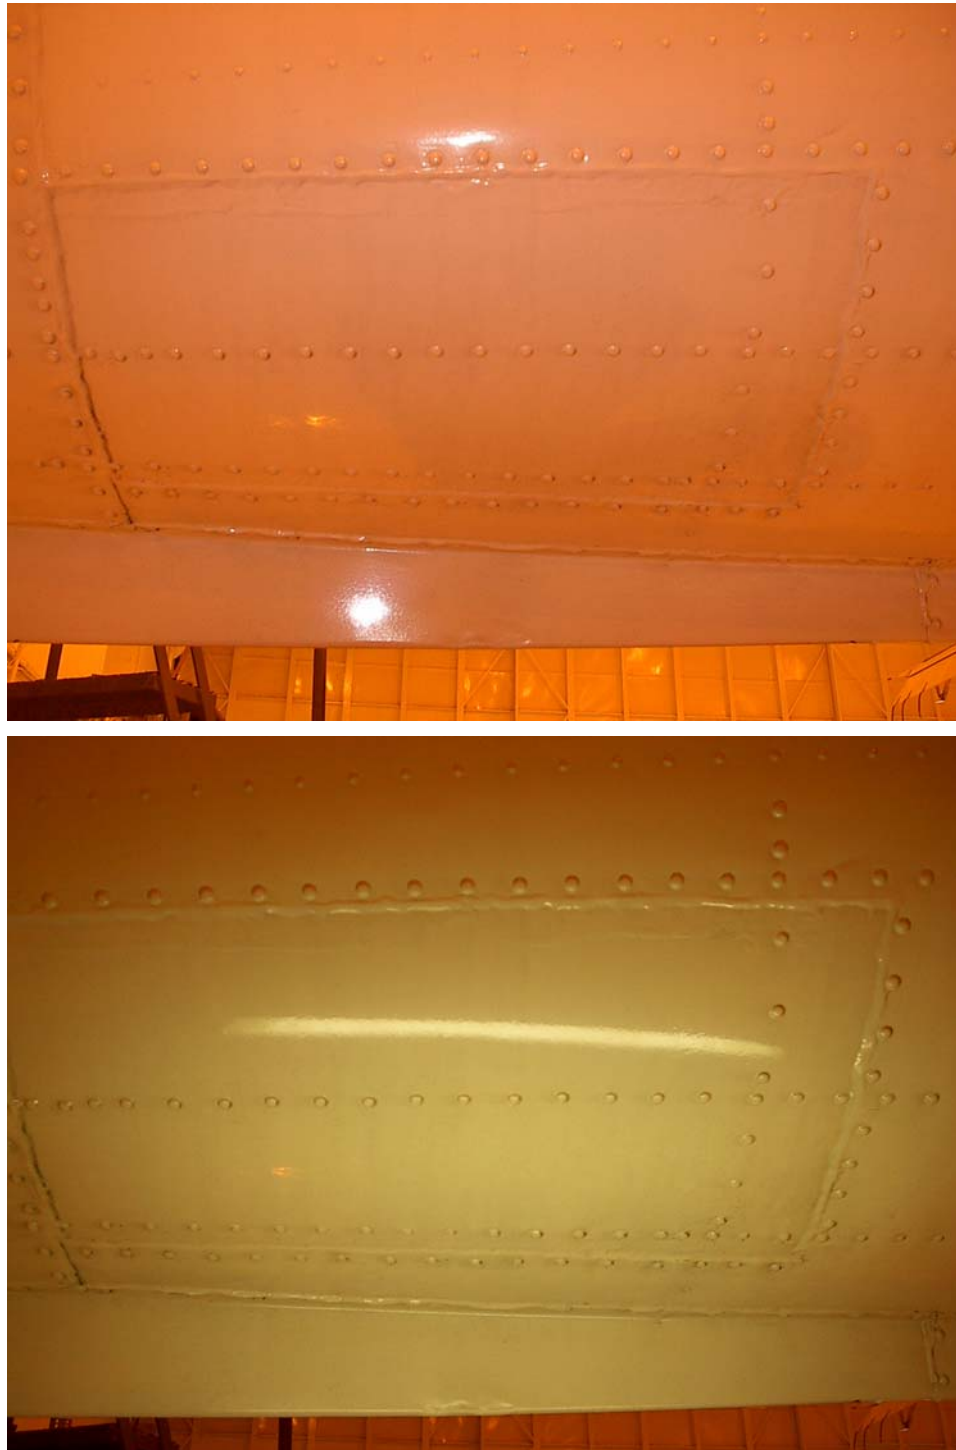
**5.4.3.21. Non-standard repair on lower Aft RH fuselage between station #367-#384**

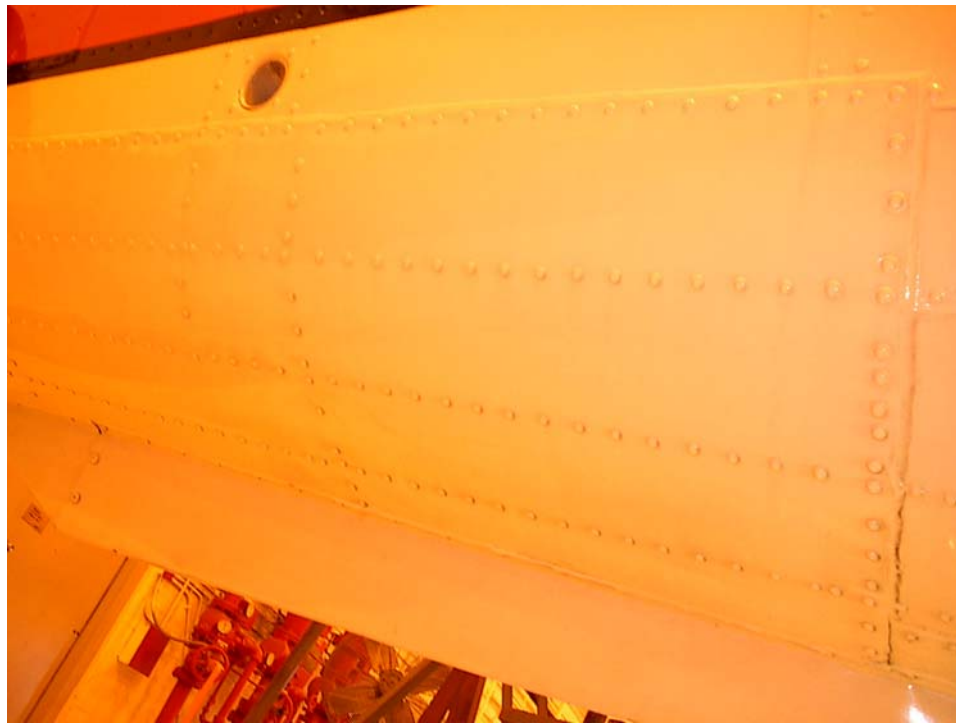
**5.4.3.22. Non-standard repair on LH and RH lower fuselage side skin adjacent to tail wheel shock strut**

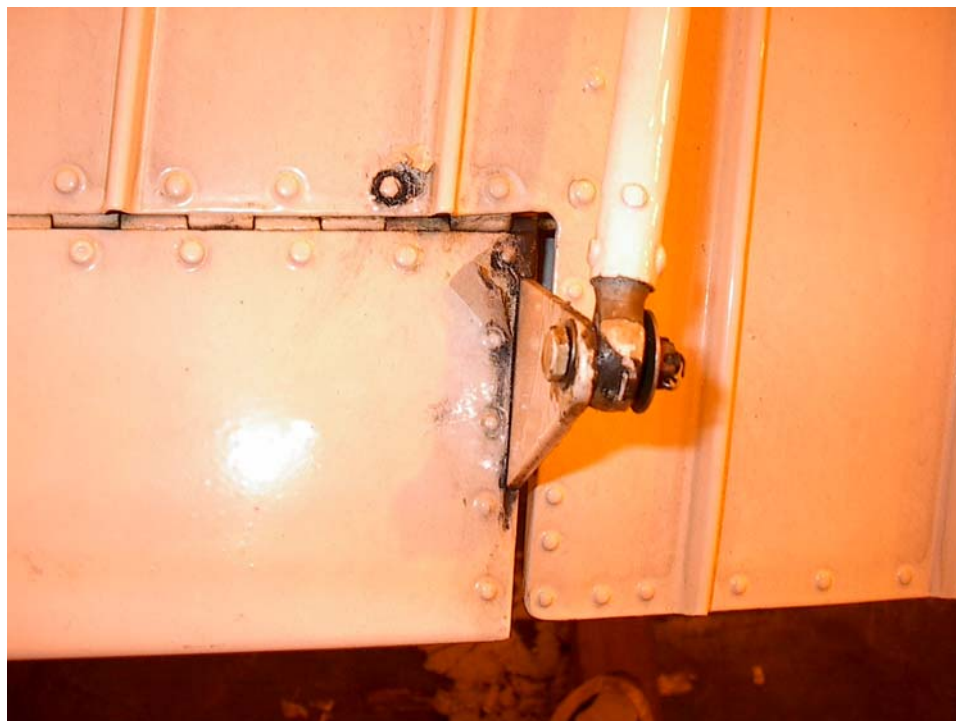
**5.4.3.23. LH elevator trim tab has multiple layers of paint making crack detection difficult.**

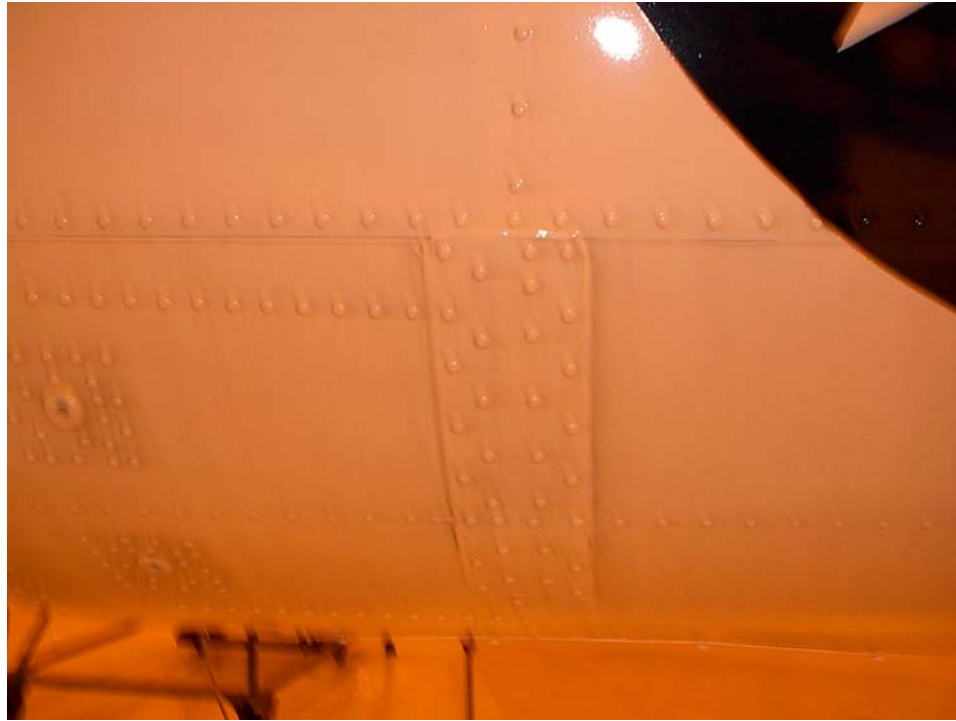
**5.4.3.24. Unapproved repairs at outer LH empennage skin at station #280**

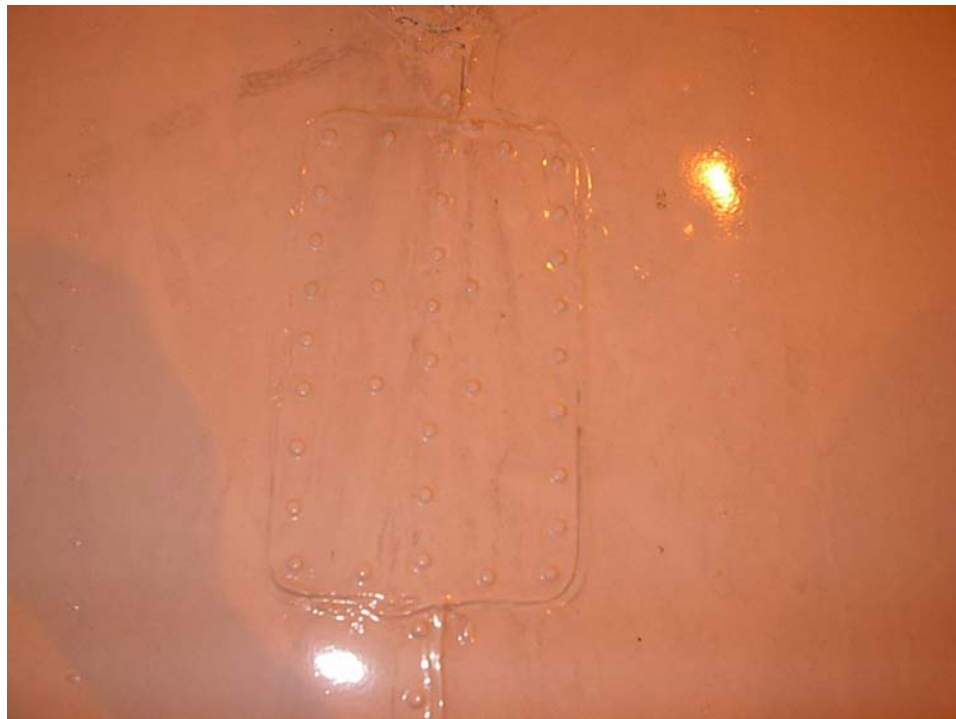
**5.4.3.25. Non-standard (unapproved) sheet metal repair on top empennage just forward of dorsal fin at station #264**
